COUNTRY LAKES DAM

NO. 1

NJ 00050

PHASE 1 INSPECTION REPORT
NATIONAL DAM SAFETY PROGRAM

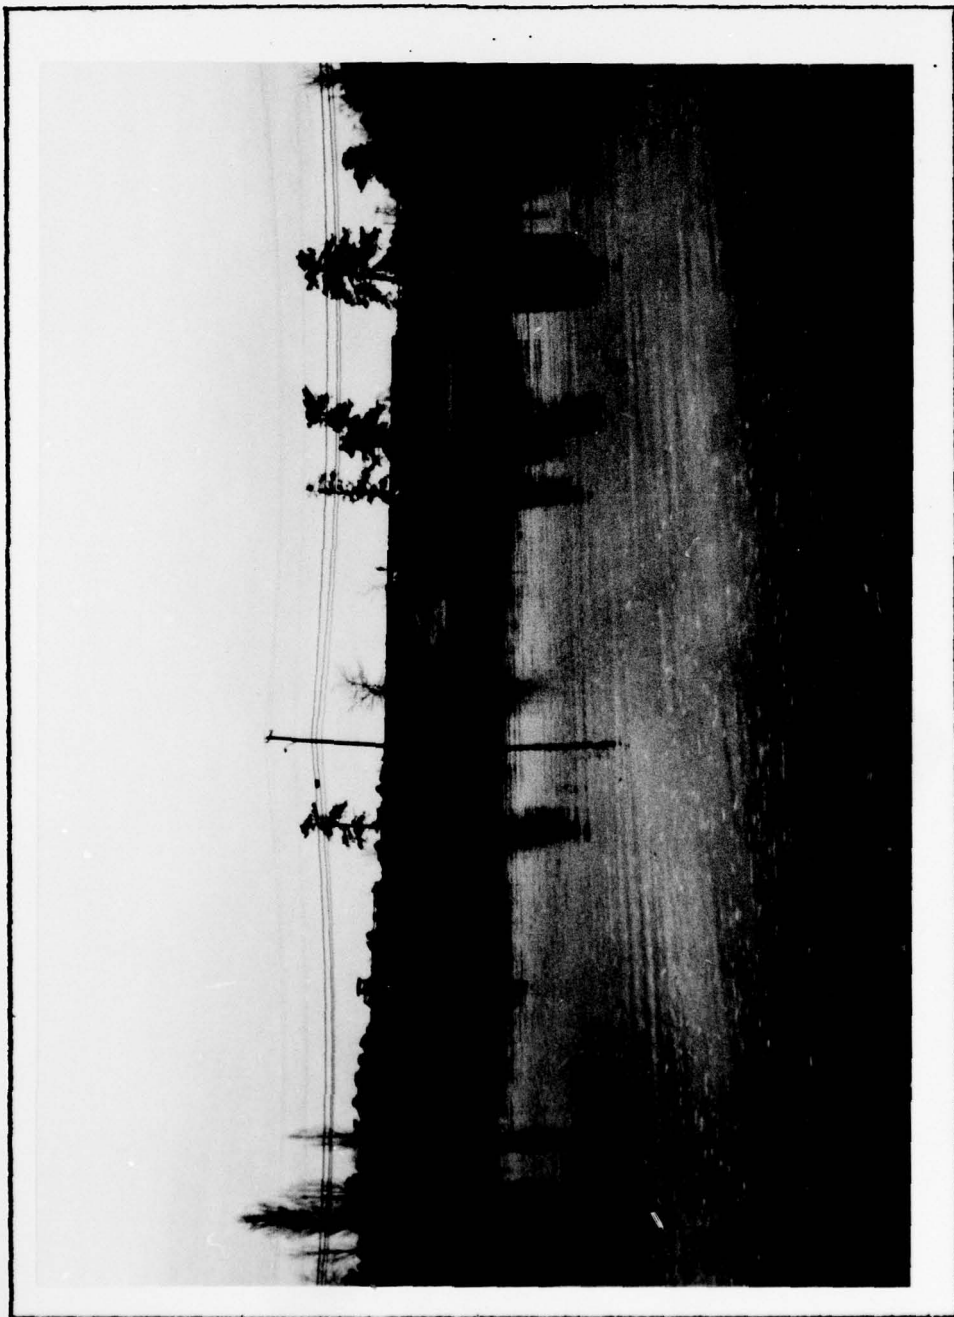
*OVERVIEW OF THE EMBANKMENT AND SPILLWAY LOOKING UPSTREAM
COUNTRY LAKES DAM NUMBER ONE, BURLINGTON COUNTY, NEW JERSEY*

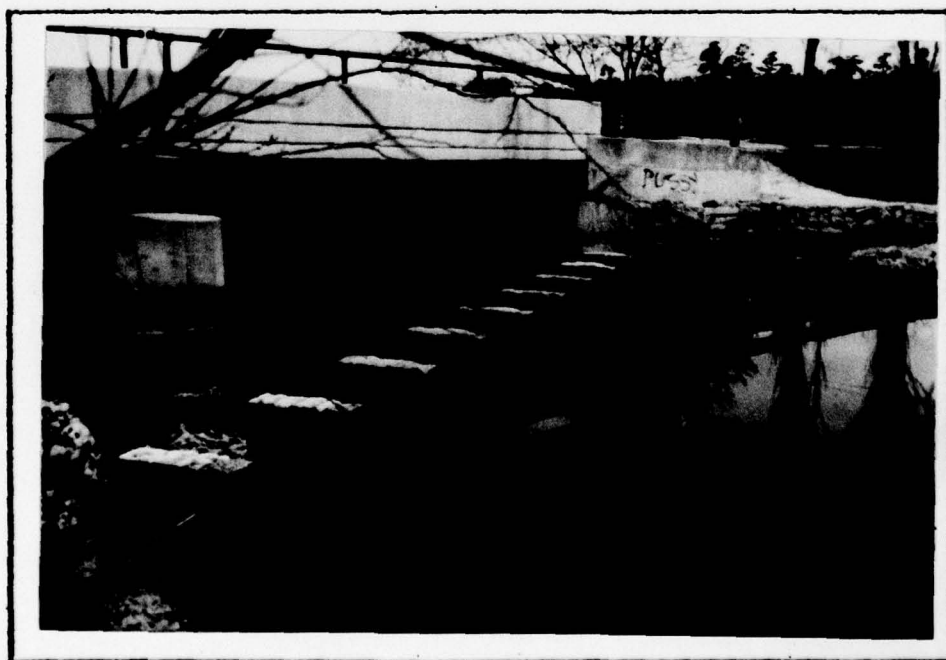
*SPILLWAY STOPLOG PIERS
AND THE BRIDGE OPENING 4/12/79*

(1) A service bridge should be provided to facilitate the removal of stop logs.

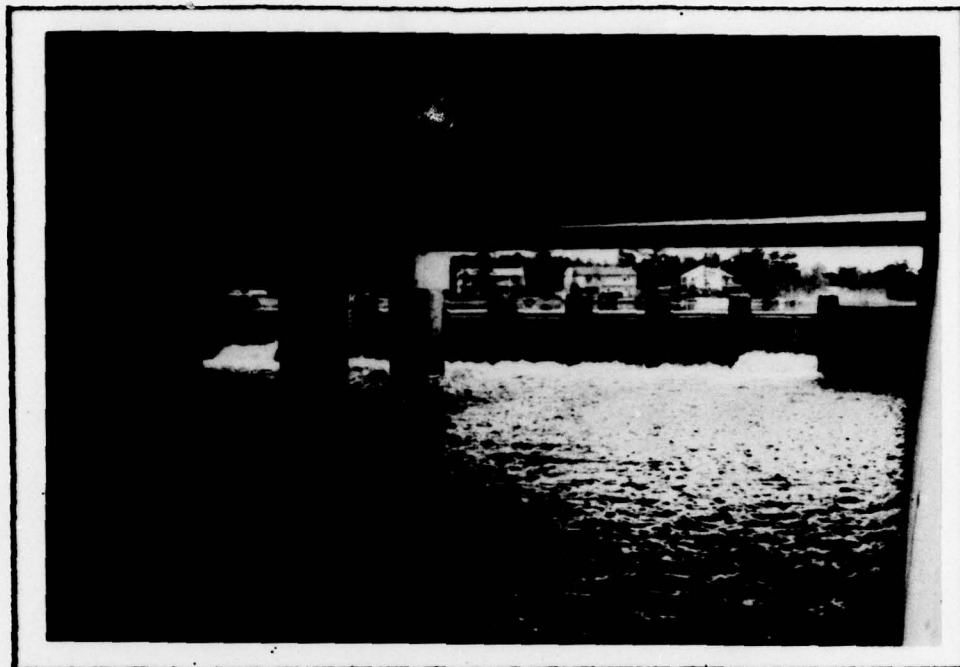
*VIEW OF THE BRIDGE OPENING
AND THE SPILLWAY STOPLOG PIERS 4/12/79*

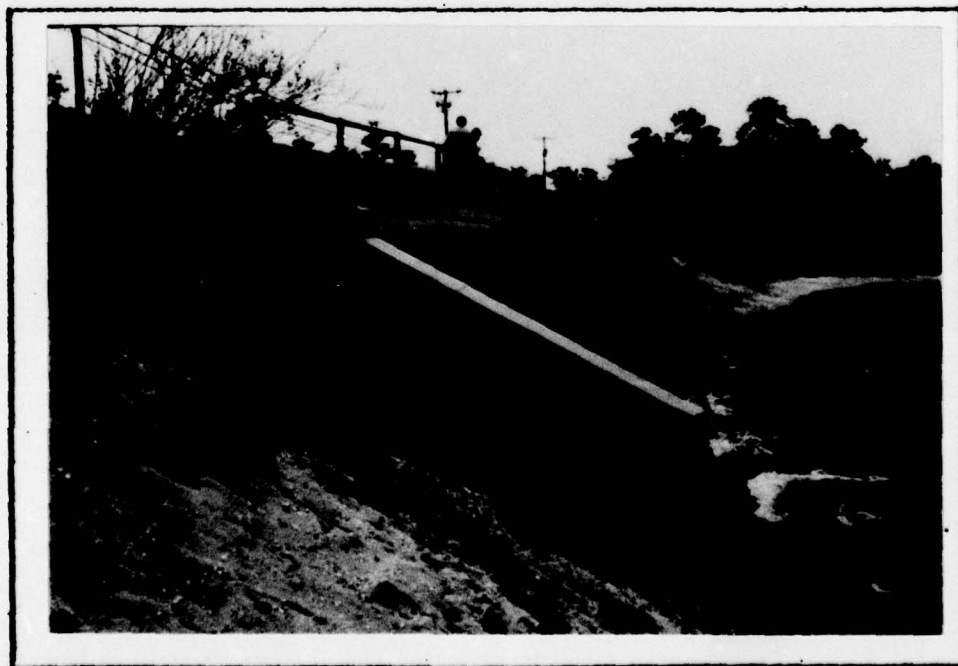
*DOWNSTREAM FACE OF THE
EMBANKMENT AND BRIDGE 4/12/79*

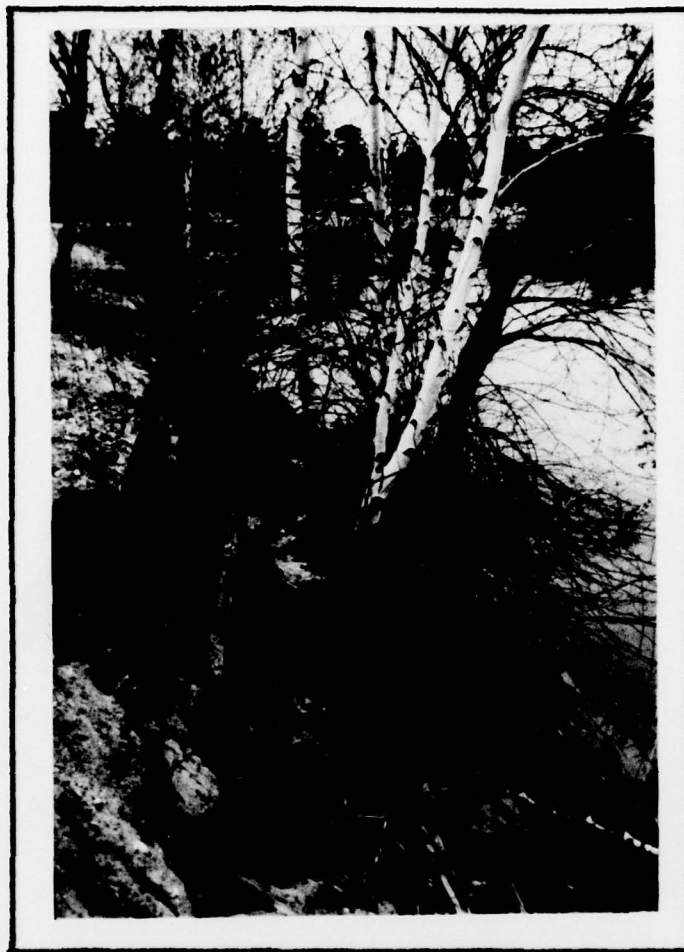
DOWNSTREAM FACE OF
THE EMBANKMENT
SHOWING DEBRIS
AND TREES
4/12/79

(4) Trees and brush should be removed from the embankment and the areas where trees have been removed should be backfilled and regraded.

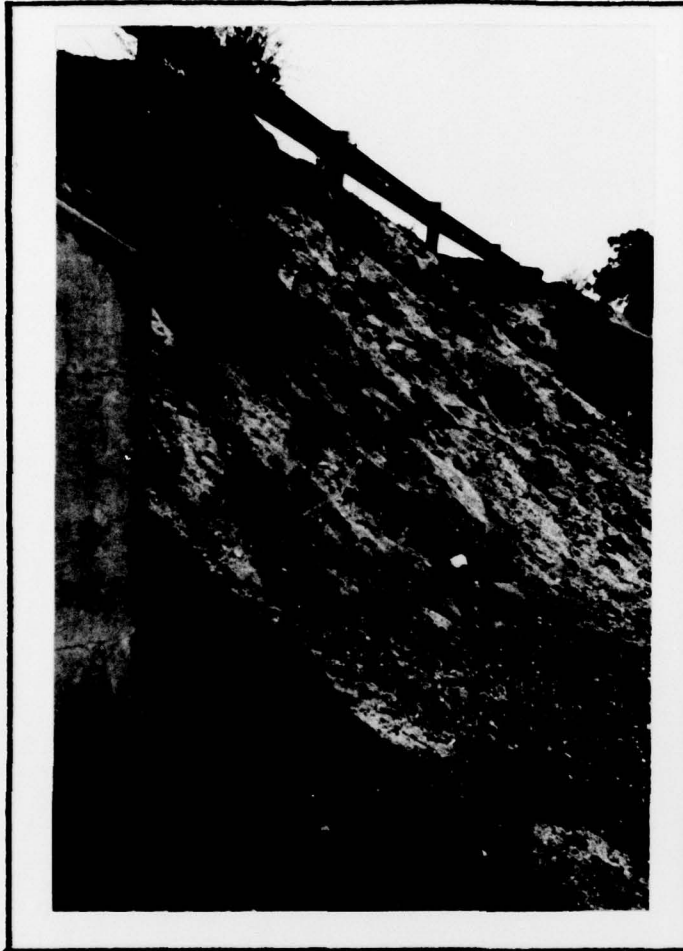
*DOWNSTREAM FACE OF
THE EMBANKMENT
SHOWING EROSION
AND LACK OF COVER
4/12/79*

(3) Areas below design elevation should be filled and compacted to restore the embankment to design elevations and slopes. The embankment slopes should be protected with vegetative cover or riprap.

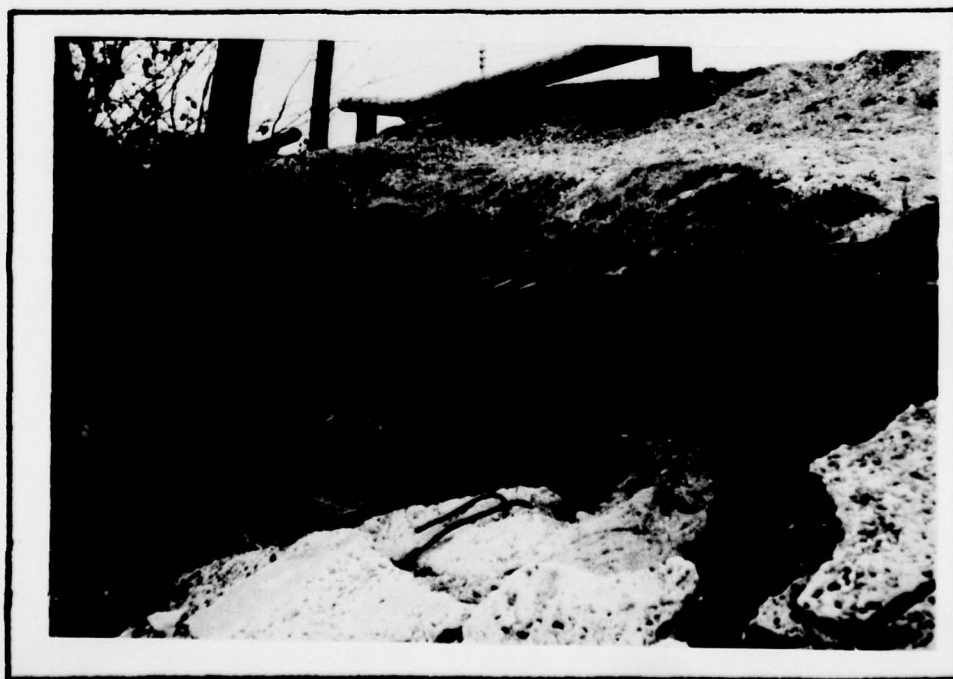
*DOWNSTREAM FACE OF THE EMBANKMENT SHOWING
EROSION AND MATERIALS INCLUDED IN THE EMBANKMENT* **D-4**

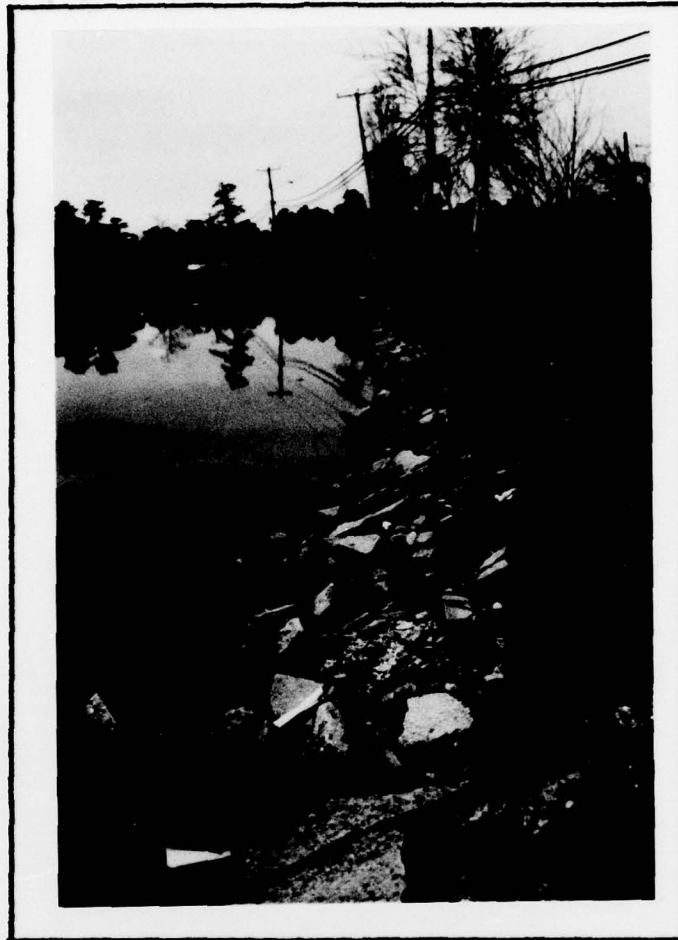
**UPSTREAM FACE OF
THE DAM FROM THE
RIGHT ABUTMENT**

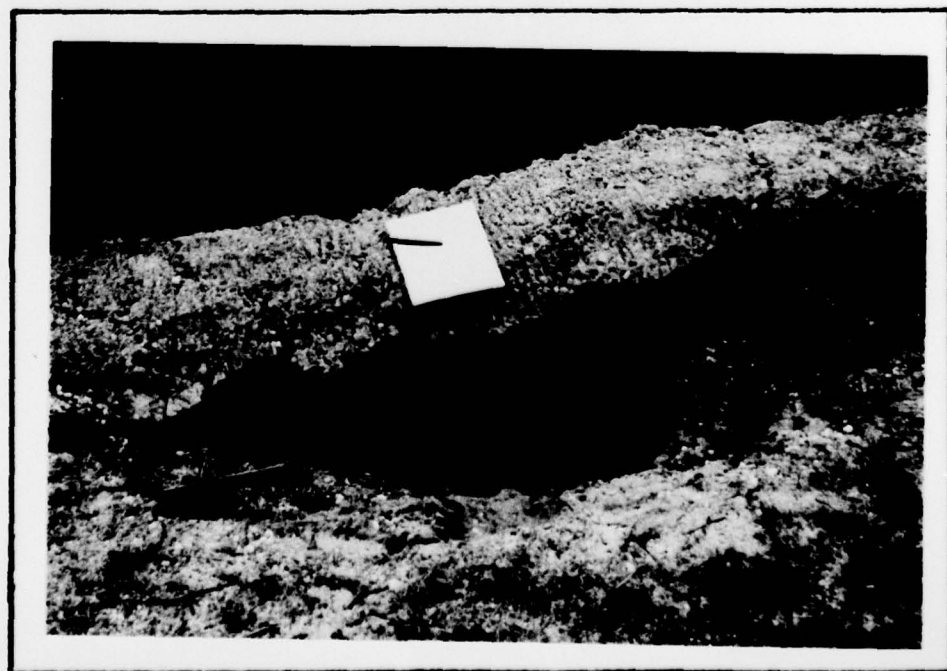
<u>VISUAL EXAMINATION OF</u>	<u>OBSERVATIONS</u>	<u>REMARKS OR RECOMMENDATIONS</u>
JUNCTION OF EMBANKMENT AND ABUTMENT, SPILLWAY AND DAM	Some slight undermining was observed at the junction of embankment and upstream and downstream retaining walls.	These areas should be backfilled and compacted with suitable material
ANY NOTICEABLE SEEPAGE	None Observed	
STAFF GAGE AND RECORDER	None Observed	
DRAINS	None Observed

**UNDERMINING OF THE BLOCK WALL ALONG
THE UPSTREAM EMBANKMENT SLOPE**

(2) In several areas erosion of the embankment is taking place behind the upstream and downstream retaining walls. These areas should be backfilled and compacted with suitable material.
